**Direct Image Comparison to Replicate Image SEE-3D Report**

**Preliminary Technical Report**

**TR-363**

To statistically compare the surface finish and image quality between direct imaging and replicate imaging of the cylinder bore surface

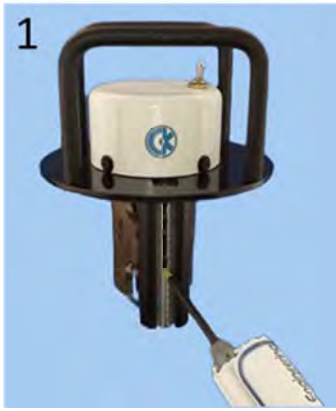
Replicate material is dispensed into replicate bar

The CKE SEE-3D cylinder bore surface finish qualification system utilized in this study consists of three components. The first is the SEE-3D replicate head, which is a nondestructive cylinder bore replicating device utilizing a proprietary replicate material to create high resolution molds of the bore surface. The second component to the SEE-3D system is the white light interferometer used to map the surface of the mold in three dimensions. And the third is the customized SPIP software that quantifies up to thirty 2D and 3D surface characteristics. This system allows for quick, accurate and nondestructive cylinder bore surface finish analysis that can be used to control finishing processes and reduce wear and oil consumption in internal combustion engines. The four main steps of the process can be seen in the images on page 3.

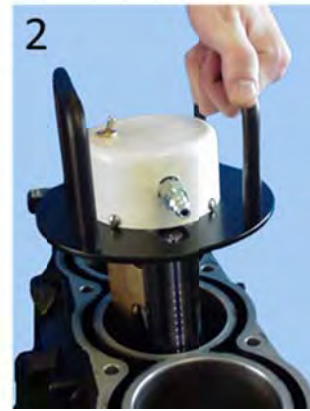
Replicator head is inserted into bore

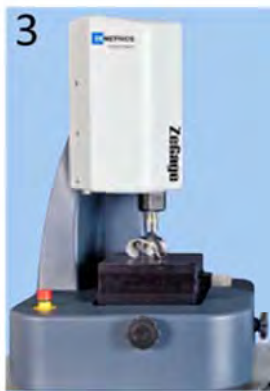
SEE-3D replicate is examined with interferometer

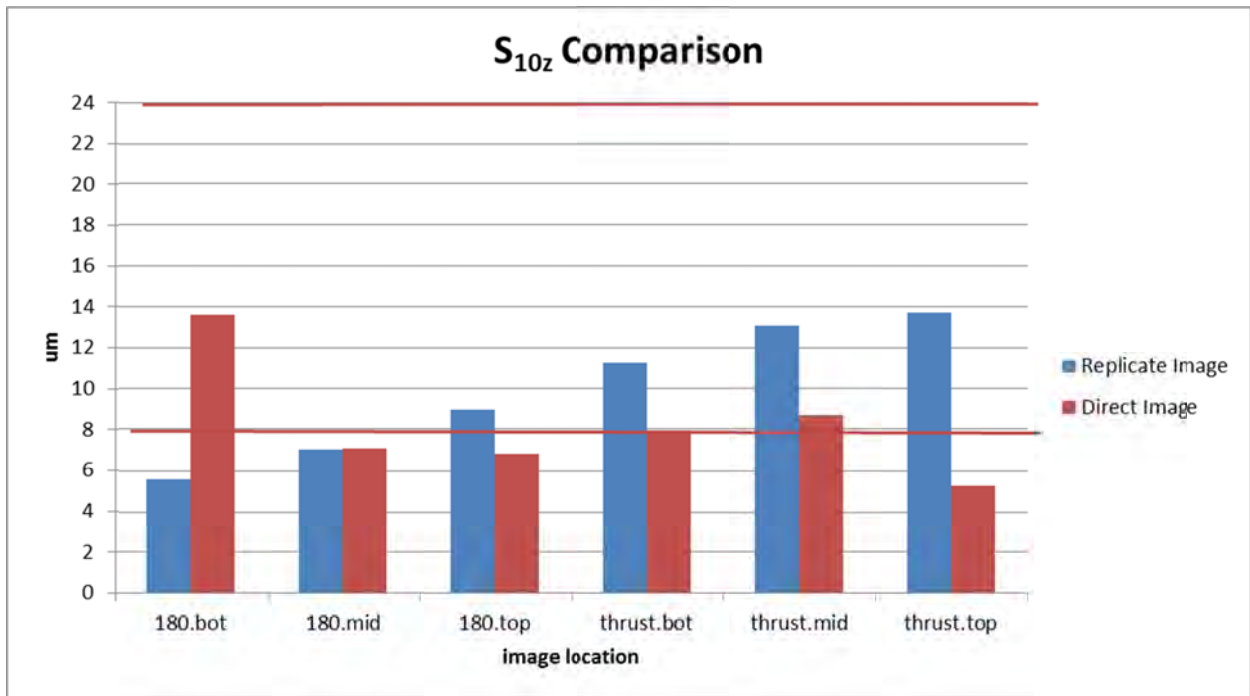
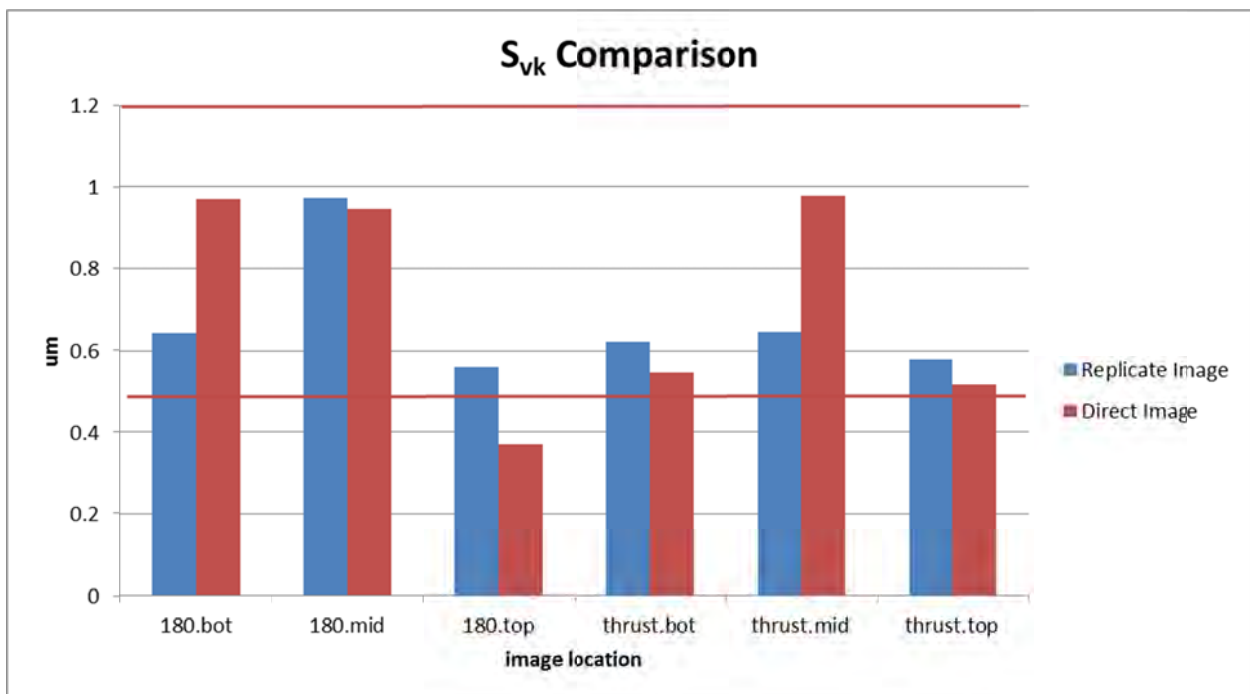
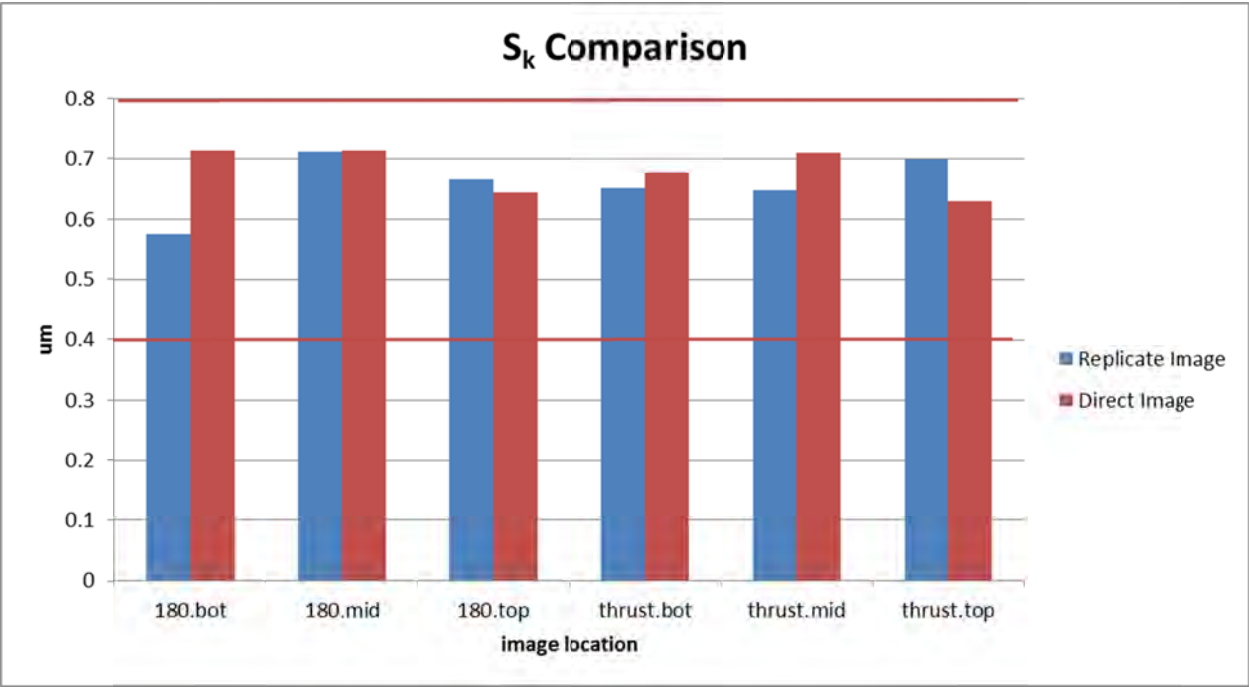
- Comparison Charts of Wash Cylinder, showing the strong correlation in surface finish values derived from direct surface and replicate analysis.

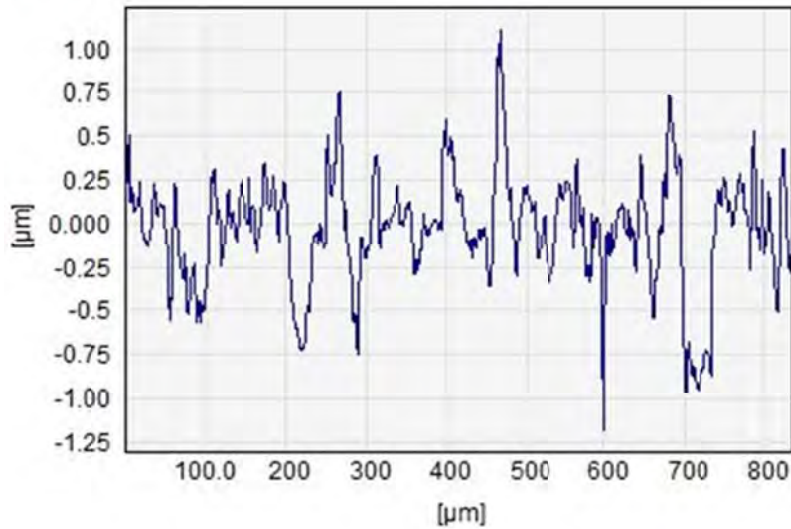
Figure 15: Direct Surface Roughness Trace Example from Appendix I

Figures 14 and 15 show typical 2D traces from Replicate and Direct Images.
